Subject: Phase I Environmental Site Assessment
Industrial-Manufacturing-Light Property
10793 West 20 1/2 Street
San Luis, Arizona 85349
Wells Fargo Bank RETECHS Project No.: LA10-24445-09-A.2-ACP

EXECUTIVE SUMMARY

PHASE I ENVIRONMENTAL SITE ASSESSMENT
10793 WEST COUNTY 20 1/2 STREET
SAN LUIS, ARIZONA

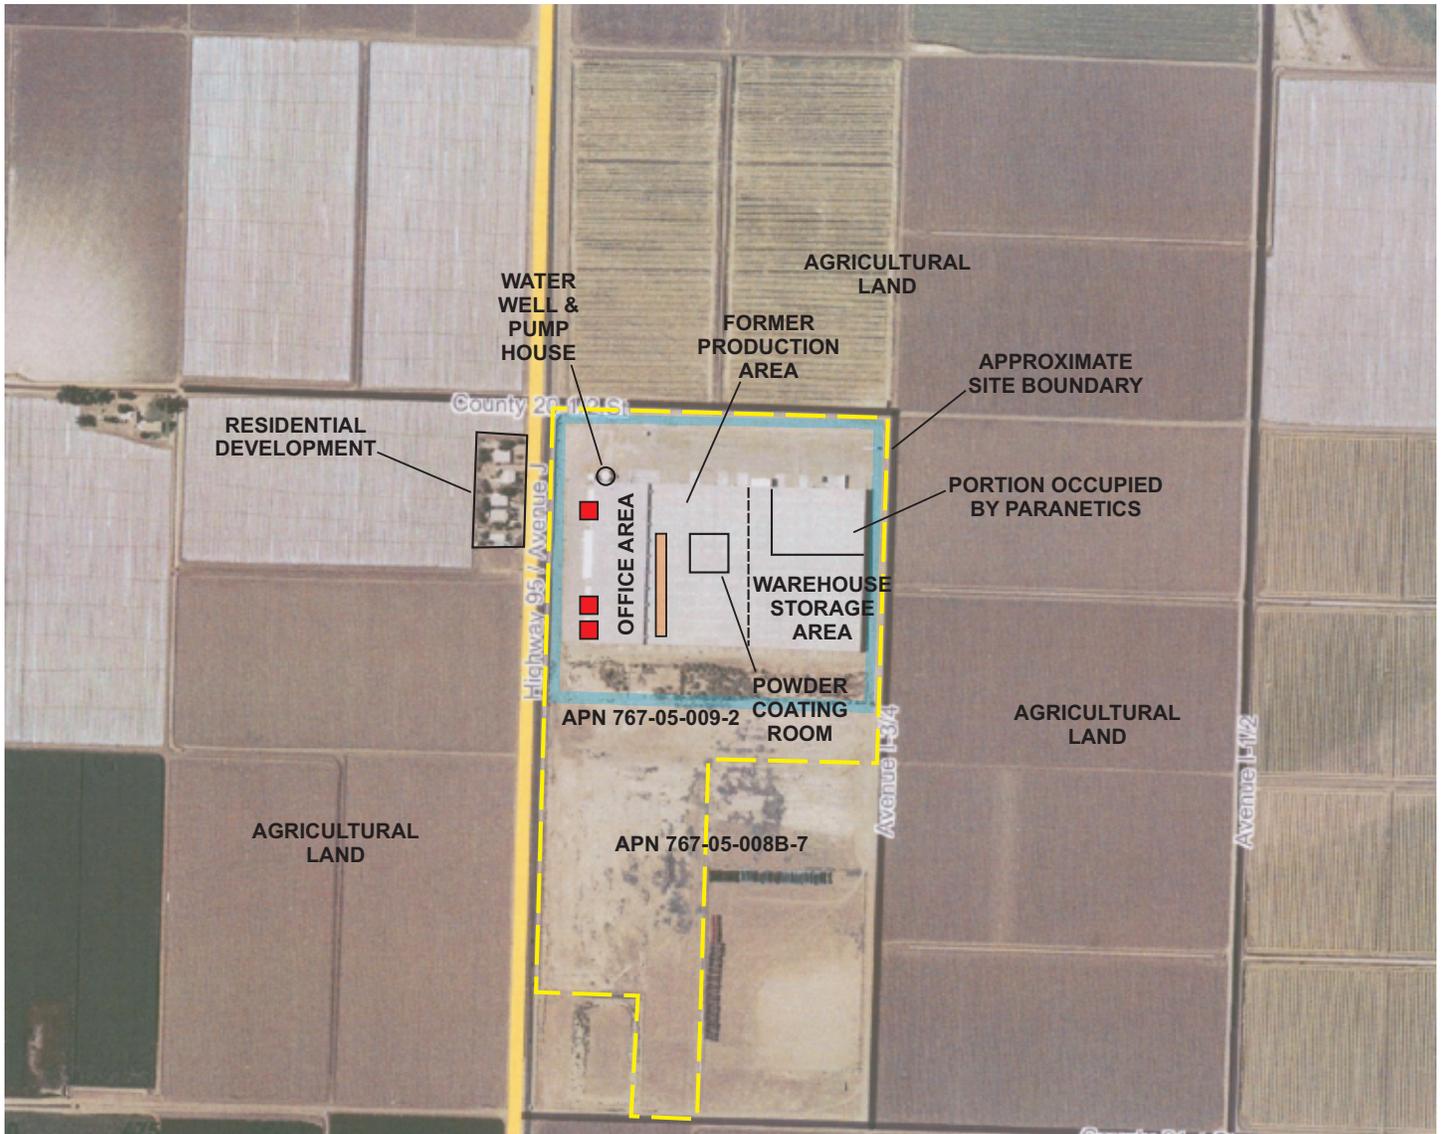
1

LEGEND	
■	Approximate Location of Pad-Mounted Transformer
	Approximate Location of Concrete Trench and Pit
	Retention Basin

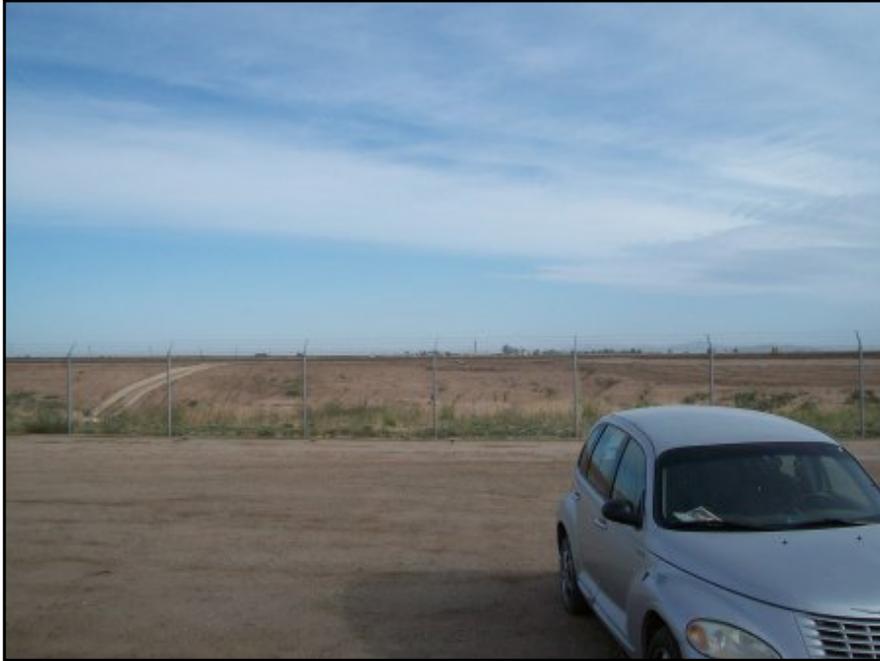
View of a retention basin followed by agricultural land located north of the site;
view to the north.

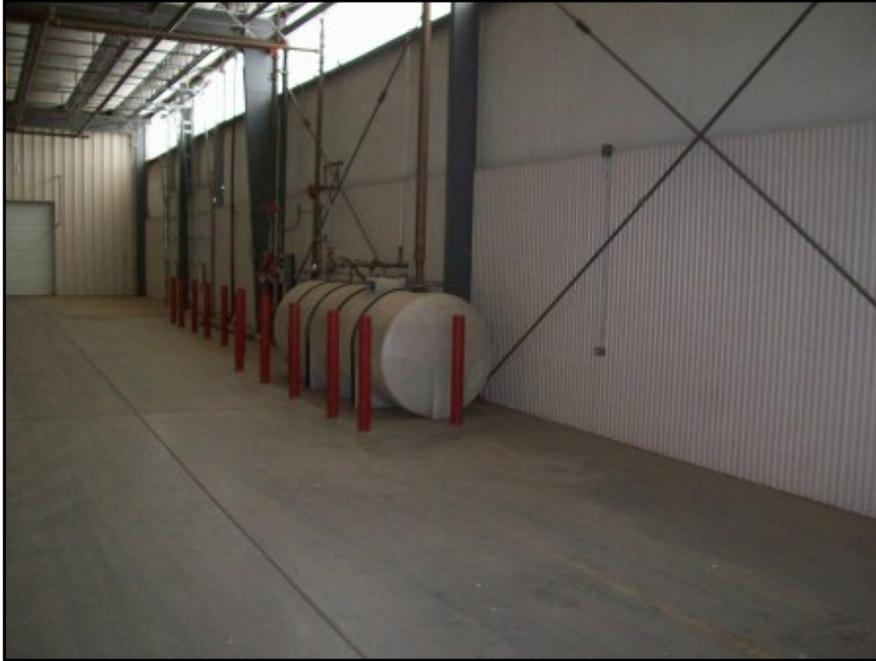
1,000 gallon water tank used for the evaporative cooling system.

Additionally, two 1,000-gallon aboveground water tanks were observed in the north-central portion of the warehouse and in the southwestern portion of the warehouse. It appears likely the two 1,000-gallon tanks were used for the evaporative cooling system for the facility. At the time of reconnaissance, the two tanks were empty. Therefore, Ninyo & Moore does not consider the two 1,000-gallon ASTs to be a REC for the site.

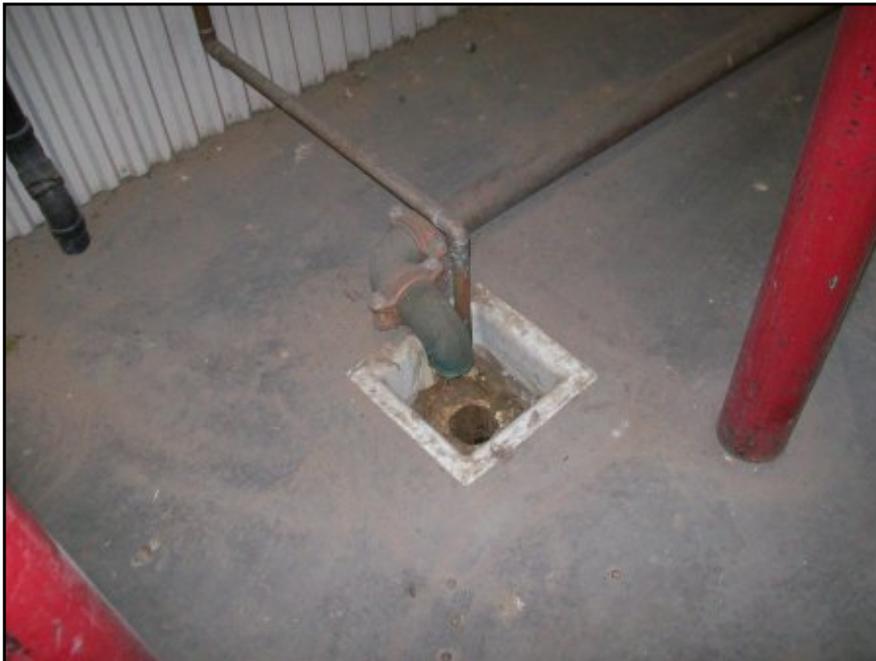
Floor drain located within the warehouse storage area of the site.

Floor drains were observed along the northern wall within the warehouse portion at the site. These drains likely received water associated with standard housekeeping practices. Additionally, these floor drains were located within the former warehouse portion of the site structure, where Meadowcraft, Inc. stored and distributed furniture. Additionally, these floor drains were not located in the production areas of the site, where hazardous substances were historically used in the fabrication process. Indications that petroleum products and/or hazardous substances were disposed in these drains was not observed during the reconnaissance. Therefore, Ninyo & Moore does not consider the floor drains to be a REC for the site.

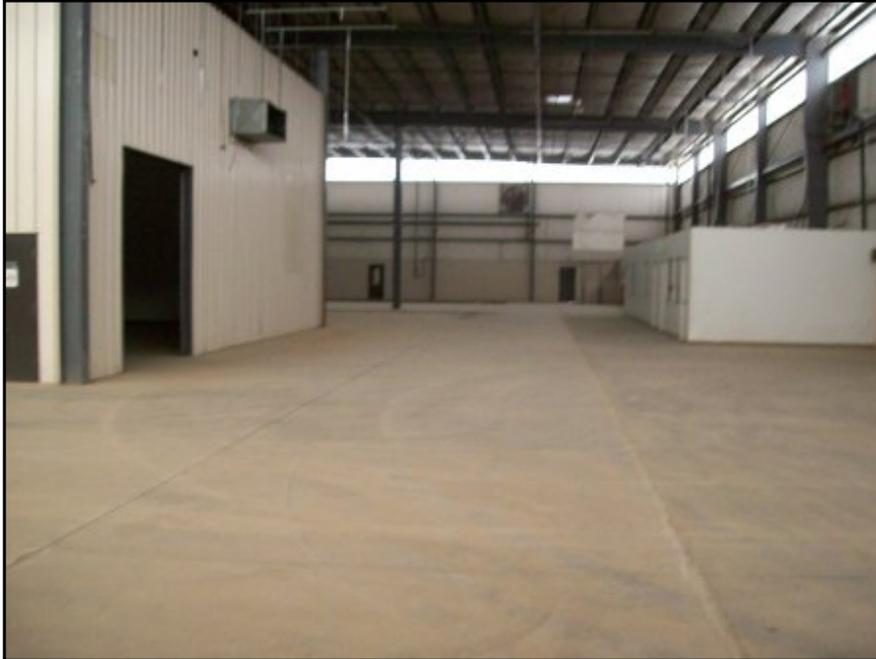
Former production area, located in the western portion of the site structure.

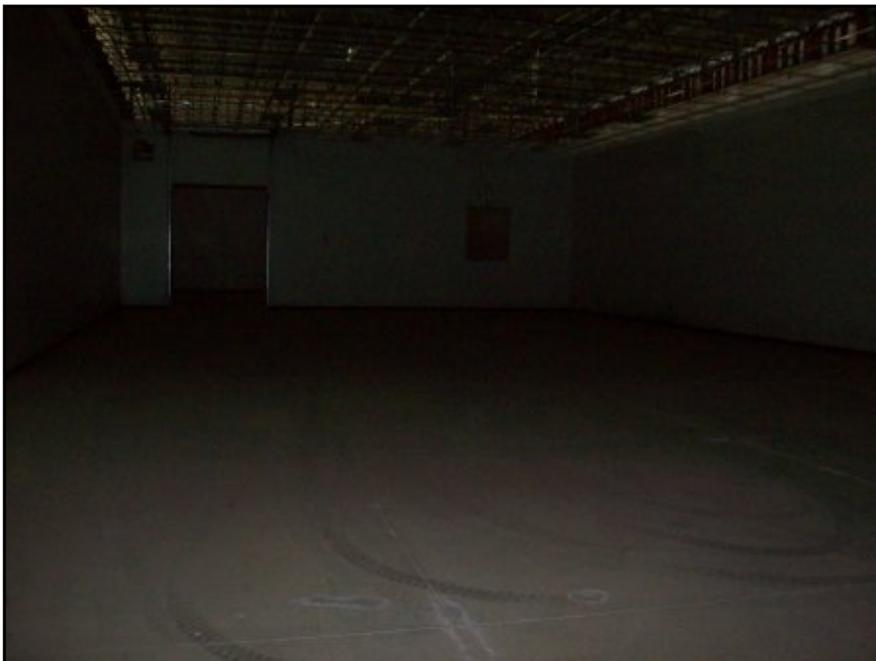
Interior of the powder coating room in the former production area.

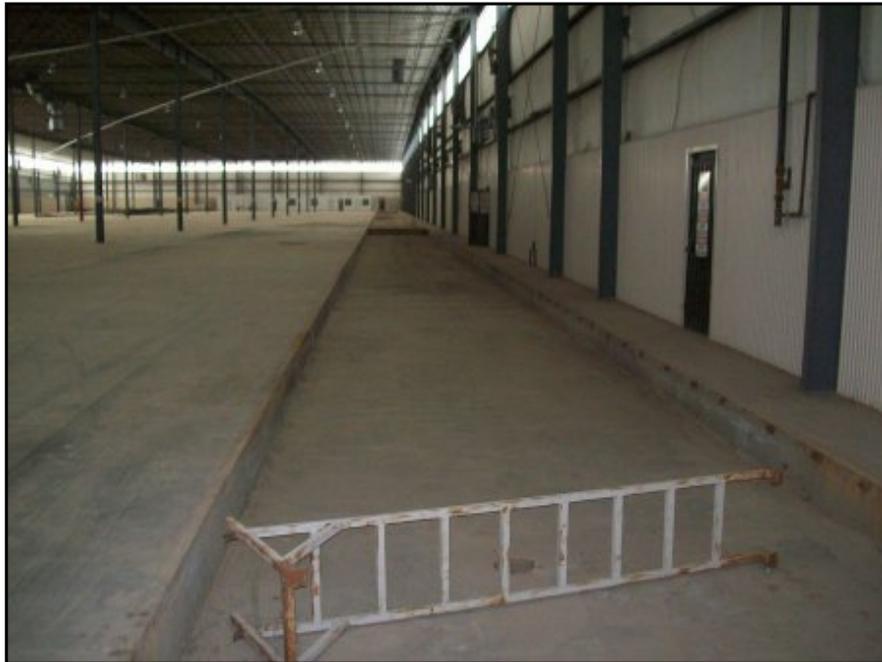
Wastewater trench located along the western portion of the production area.

Based on the REC identified for the site, Ninyo & Moore recommends further assessment site trench and pit in an effort to evaluate the potential impact of historical site activities to the site subsurface.

Ninyo & Moore did not observe the storage and disposal of hazardous waste on site during our site reconnaissance. However, a concrete-lined floor trench and rectangular concrete pit extended along the western portion of the site warehouse building. The depth of this trench and pit were approximately 1 to 2 feet below grade. At the time of reconnaissance, the majority of the concrete within the trench was observed to be in good condition. However, several areas of stained concrete were observed within the trench and the concrete in these areas was slightly degraded. Additionally, the concrete base of the trench was jointed and several areas of staining were located along these joints. Based on our review of documents provided by ADEQ, the floor trench and pit received waste products resulting from the production processes conducted at the site. The trench and pit contents were periodically emptied into 55-gallon drums and these drums were stored in the northeast corner of the site and collected by Advanced Environmental Inc. Our review indicated that the waste generated at the site included paint, toluene, acetone, methyl ether ketone, xylene, used oil, and sludge. Based on our observations, the pit, trench, and associated staining are considered RECs for the site.

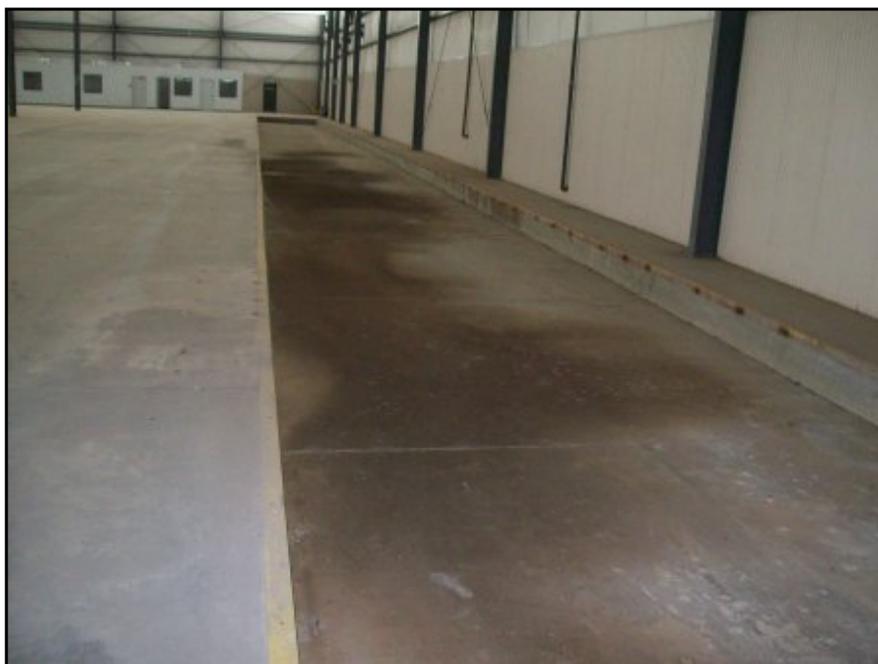
Wastewater trench and associated staining located along the western portion of the production area.

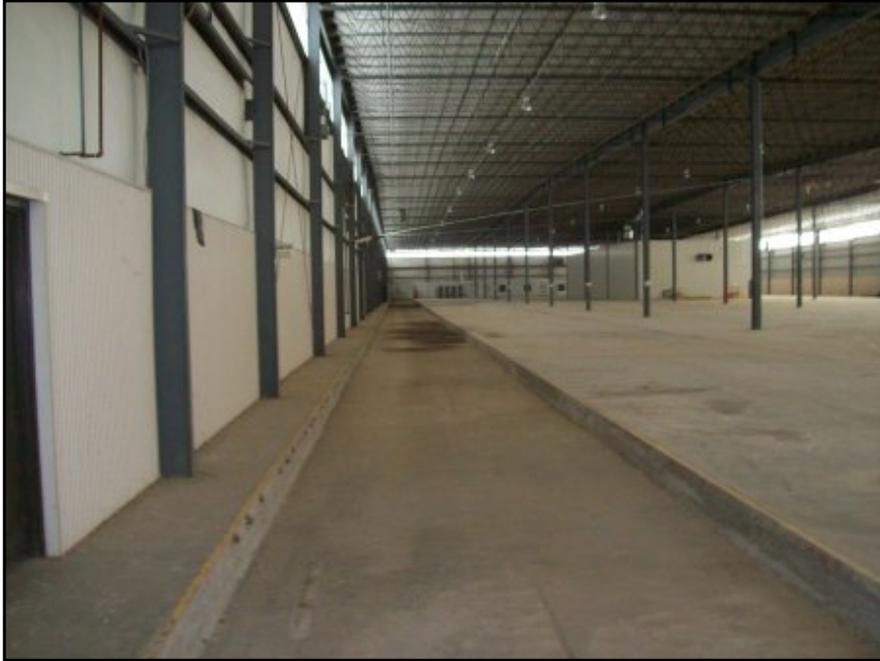
Wastewater trench and associated staining located along the western portion of the production area.

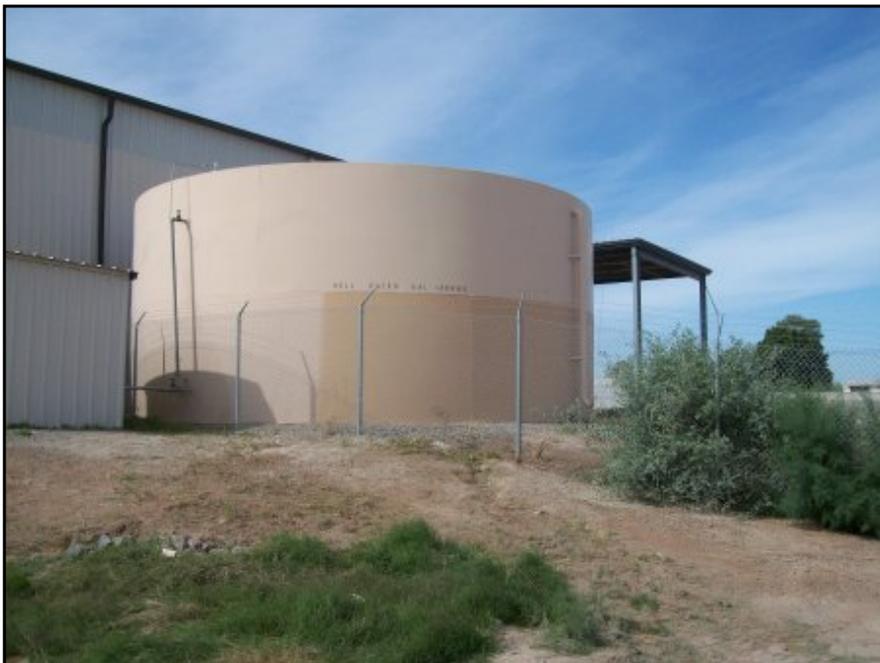
120,000-gallon water storage tank and associated pumphouse located on the northwestern portion of the site.

Potable water is provided to the site by a water well located adjacent to the northwestern corner of the facility. An associated pumphouse is located adjacent to a 120,000-gallon aboveground water storage tank. At the time of reconnaissance, Ninyo & Moore did not observe any hydraulic staining on or around the soil in the pumphouse. Therefore, Ninyo & Moore does not consider the presence of the water well and associated pumphouse to be a REC for the site.

A 120,000-gallon aboveground water storage tank was observed adjacent to the northwestern corner of the site structure. Based on our review, the water storage tank collected groundwater to be used for the fire sprinkler system within the site structure. Therefore, Ninyo & Moore does not consider the 120,000-gallon aboveground water tank to be a REC for the site.

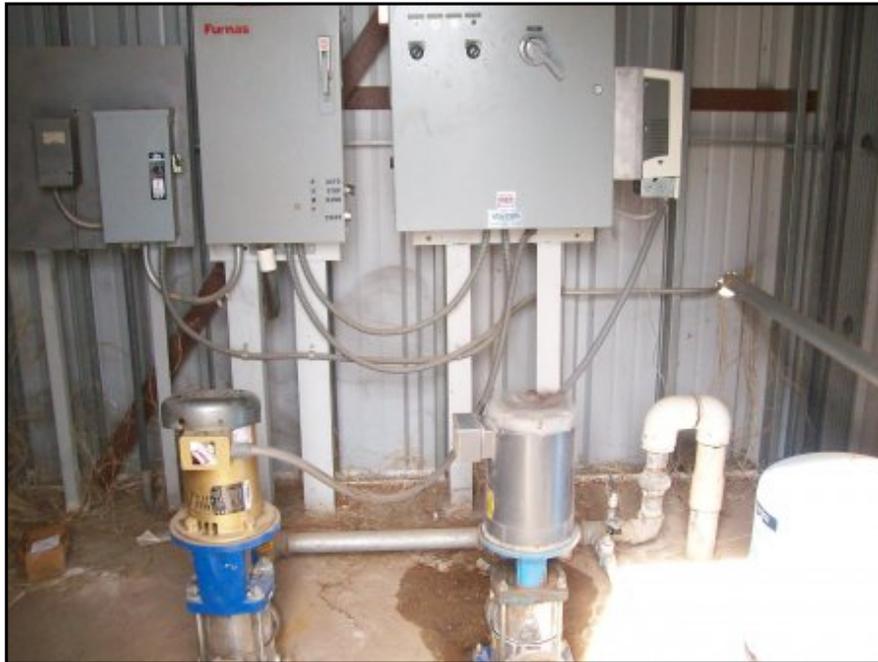
Interior of the pumphouse with no visible staining.

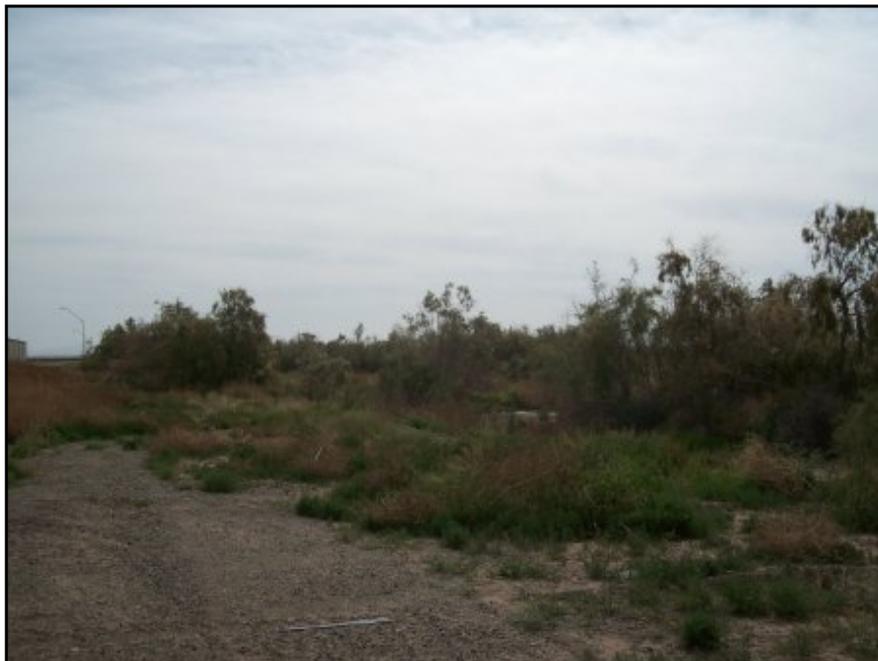
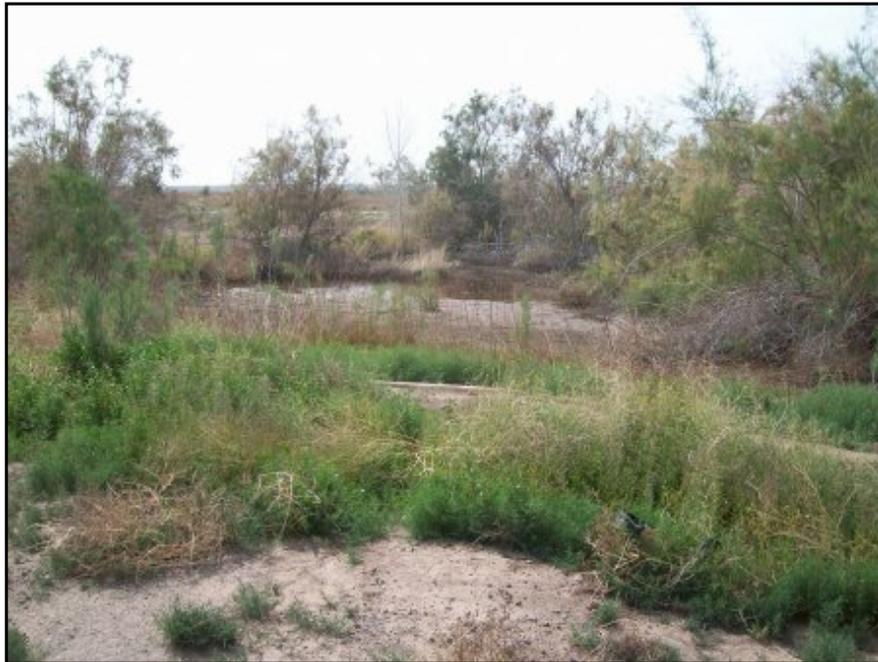
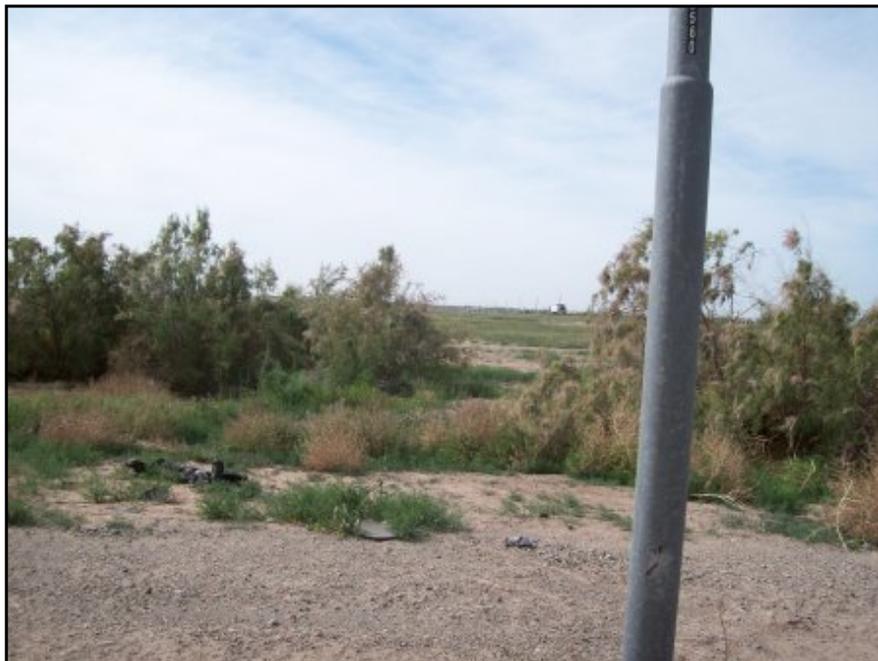
Retention areas located south of the site structure, in the undeveloped land.

Stormwater retention basins were observed along the northern, southern, western, and eastern boundaries of the site structure. These stormwater retention basins appeared to be designed to accumulate surface run-off during rainfall events from the site. During our site reconnaissance, no indications of stained soils, unusual odors, or leaks or spills of hazardous materials or petroleum products were observed within the retention basins. Additionally, the retention basins were not located downgradient of areas that used or stored hazardous materials or petroleum products. Therefore, Ninyo & Moore does not consider the presence of these stormwater retention basins to be a REC for the site.
